Single Family Home Inspection Report Sample

Property address: **13432 Anywhere Court
My town, FL 32777**

Inspection date: **Thursday, March 10, 2016**

Overview: Home is a site built wood structure, slab on grade built in 1995. The home is well built and has been well maintained. It recently received a new roof covering and the addition of ridge venting that improved attic ventilation as well as a recent exterior painting and tile flooring throughout. With the exception of the condition of the driveway there are only minor or easily corrected issues to be addressed. Detailed findings follow below.

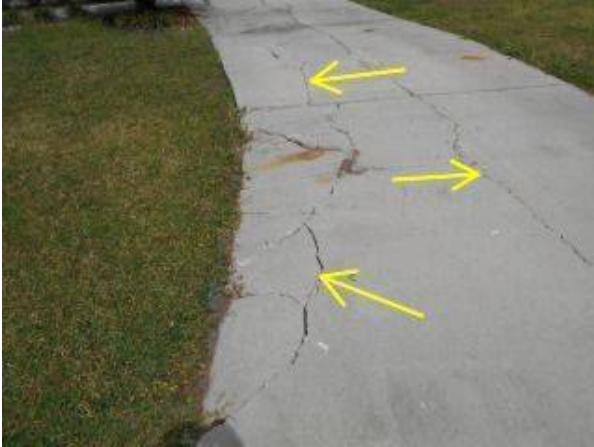
Photo 1-1

Driveway has severe cracking. Recommend replacement. Driveway concrete has been damaged by heavy vehicle. Owner says it will be repaired within a month.

driveway damage from heavy vehicle

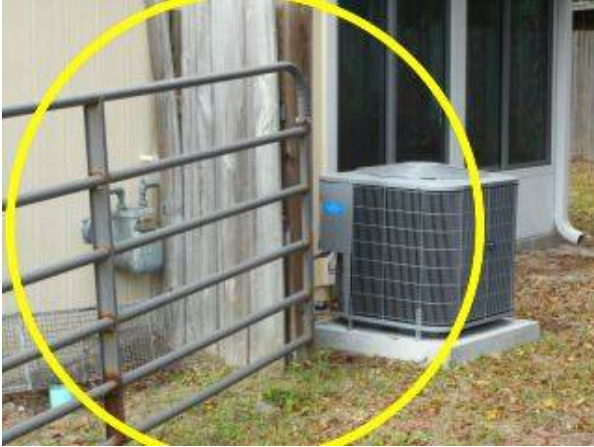
Natural gas supply meter is unprotected from damage on side of the house and is in close proximity to AC compressor unit. Recommend this situation be reviewed by the gas company and a barrier erected to prevent impact damage to the gas meter and supply.

Photo 2-1
proximity of gas meter and AC

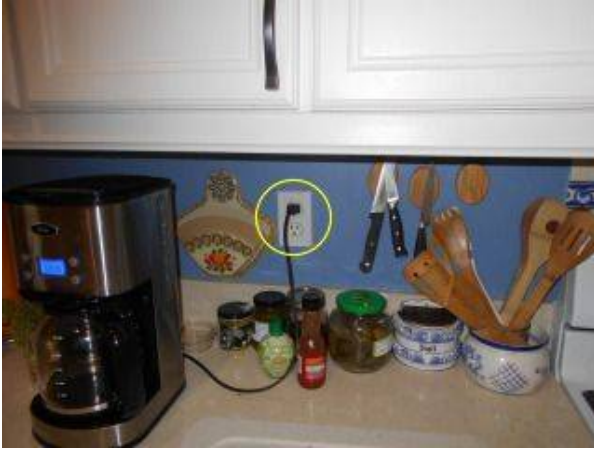
- 4) **+** Outlets in the kitchen area should be protected by GFCI breaker or the outlets themselves could be replaced with GFCI outlets. This is a safety issue. Replacement by qualified electrician is recommended.

Photo 4-1
kitchen outlet S/B GFCI

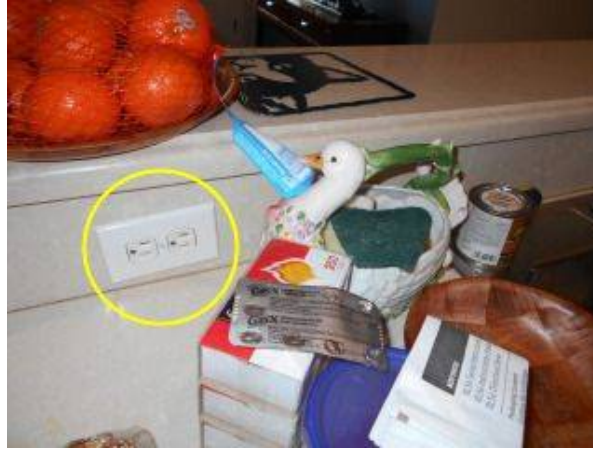
Photo 4-2
kitchen sink outlet S/B GFCI

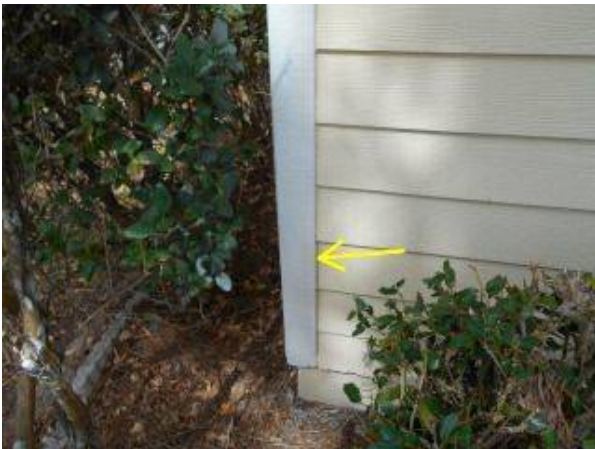
On front elevation of home natural shrinkage has opened minor cracks between siding and trim. Recommend caulking and touch up painting to prevent water intrusion. Rear and side paneling also show minor shrinkage leaving open joints. If contractor applied sealant to overlap of panels this is not an issue. Caulking and touch up is recommended if this status is unknown as a precaution against future water intrusion.

Photo 6-1
shrinkage cracks front siding to trim

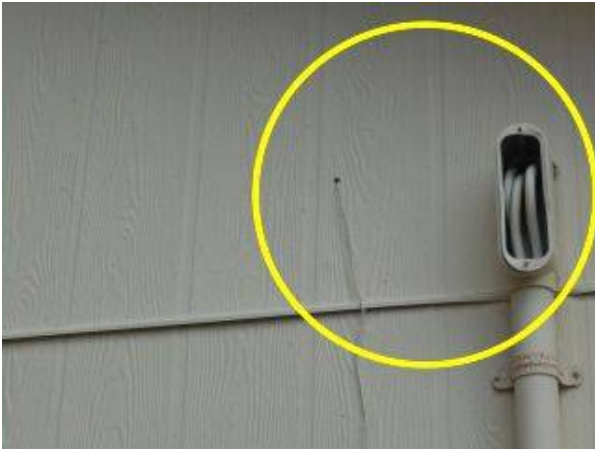
Hole where telephone wire enters home is not caulked. recommend sealing to prevent water intrusion.

Photo 7-1
missing cover and non caulked telephone wire entry

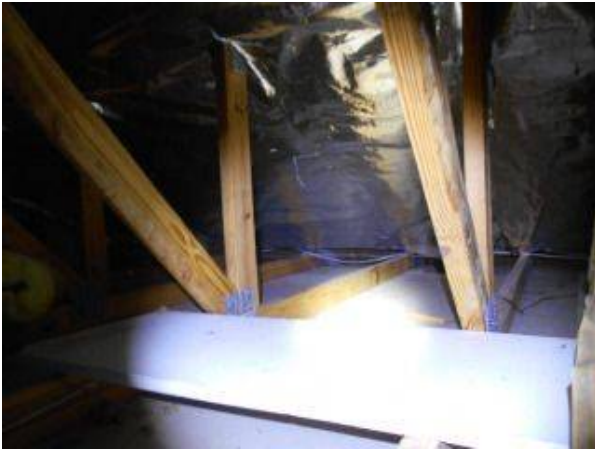
Attic structure & venting: Length of soffit venting and ridge venting is adequate for home size and by temperature rise measured appeared to be operating correctly. No signs of water intrusion were observed on structure or underside of roof decking. Reflective insulation upgrade was made several years ago and by utility useage appears very effective. Fiberglass Insulation over garage area should be replaced.

Insulation missing over garage ceiling

Photo 8-1
insul missing over garage / effective reflective insul on rafters

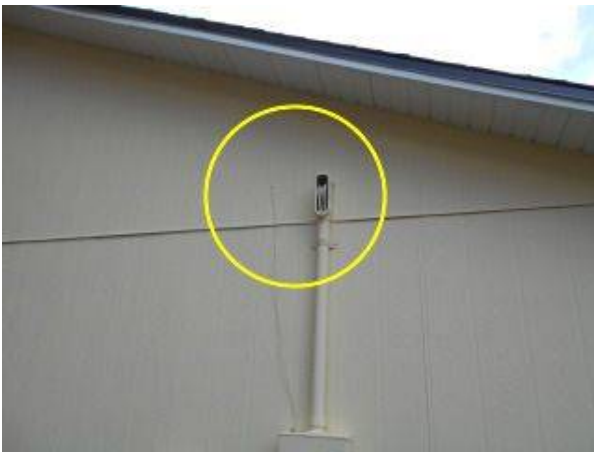
Cover missing on LB which houses service entry wires. This should be replaced to prevent rain water entry.

Photo 10-1
missing cover service entrance conduit

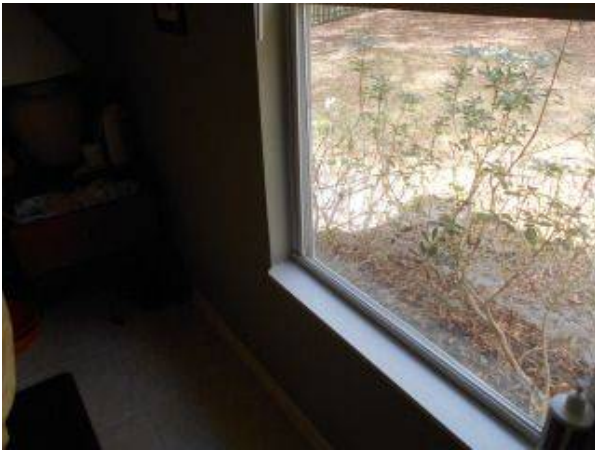
Photo X-5
Al dbl pane SH windows excellent condition

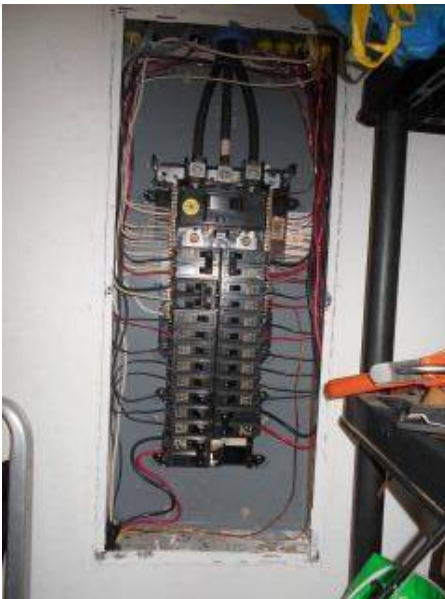
Photo X-7
Main service panel excellent condition

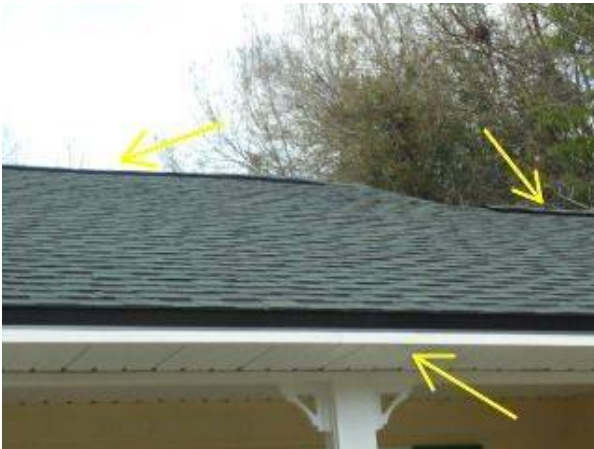
Photo X-9
New roof 3/12 pitch arch shingles ridge/soffit venting excellent

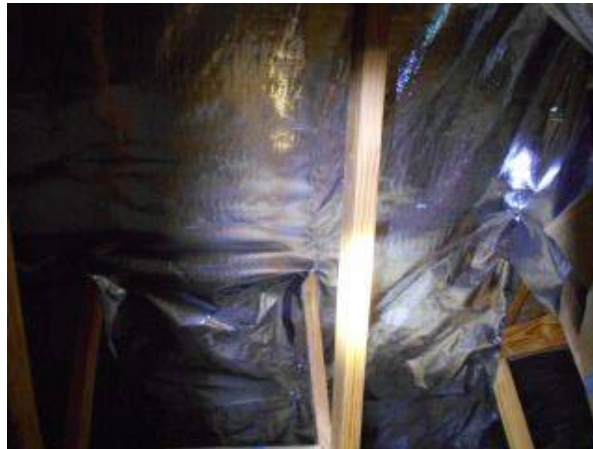
Photo X-10
effective reflective insulation

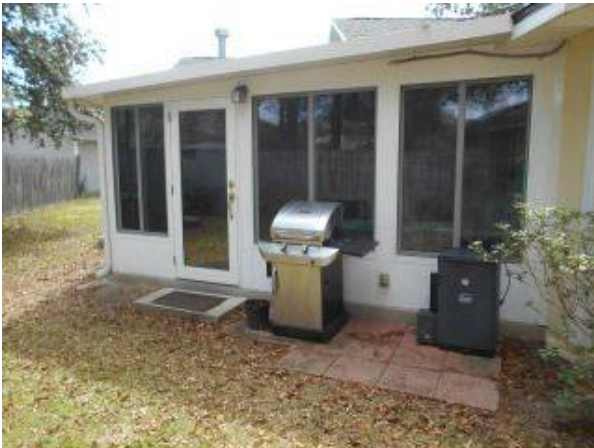
Photo X-11
sun room / hot tub area no issues observed

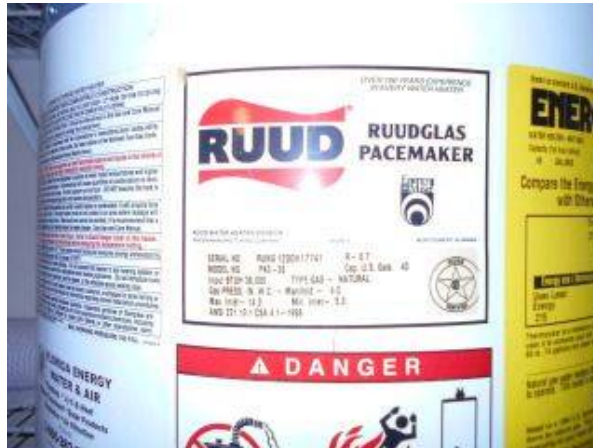
Photo X-12
4 yr old gas water heater working well
