Informed Inspection, Inc.

Single Family Home Inspection Report Sample

Property address: **13432 Anywhere Court
My town, FL 32777**

Inspection date: **Thursday, March 10, 2016**

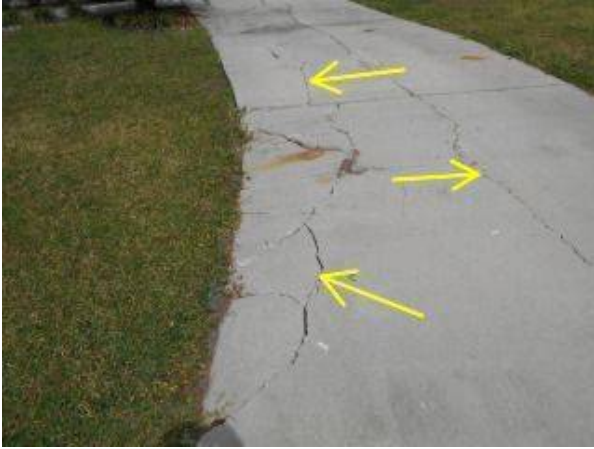
Photo 1-1

- Driveway has severe cracking. Recommend replacement. Driveway concrete has been damaged by heavy vehicle. Owner says it will be repaired within a month.

Driveway has severe cracking. Recommend replacement. Driveway concrete has been damaged by heavy vehicle. Owner says it will be repaired within a month.

driveway damage from heavy vehicle

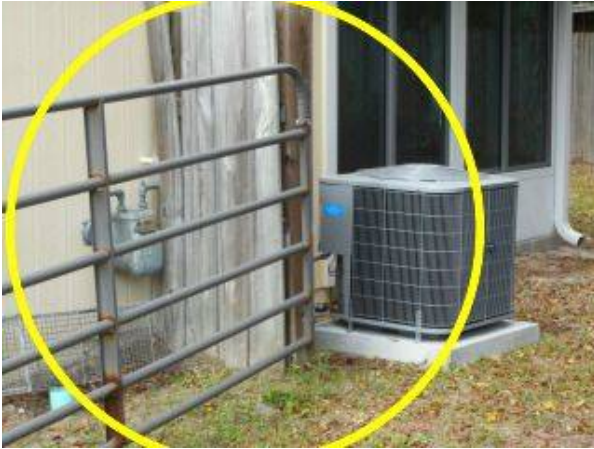
- Natural gas supply meter is unprotected from damage on side of the house and is in close proximity to AC compressor unit. Recommend this situation be reviewed by the gas company and a barrier erected to prevent impact damage to the gas meter and supply.

Natural gas supply meter is unprotected from damage on side of the house and is in close proximity to AC compressor unit. Recommend this situation be reviewed by the gas company and a barrier erected to prevent impact damage to the gas meter and supply.

Photo 2-1
proximity of gas meter and AC

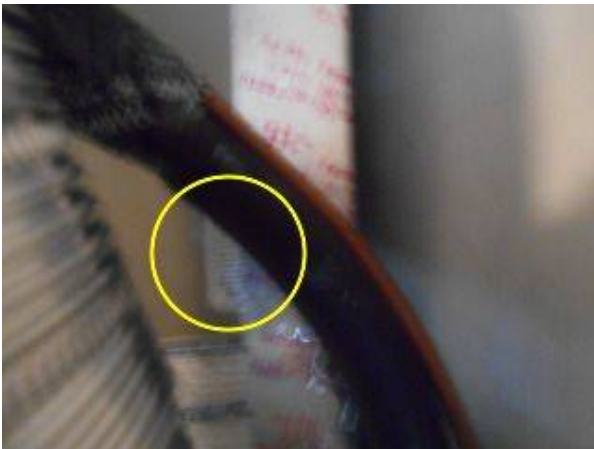
- Heater/air handler information label was covered at time of installation. This information should be available for service personnel. Recommend the information be located in units documentation and made readily accessible for service personnel to use.

Heater/air handler information label was covered at time of installation. This information should be available for service personnel. Recommend the information be located in units documentation and made readily accessible for service personnel to use.

Photo 3-1
air handler label covered

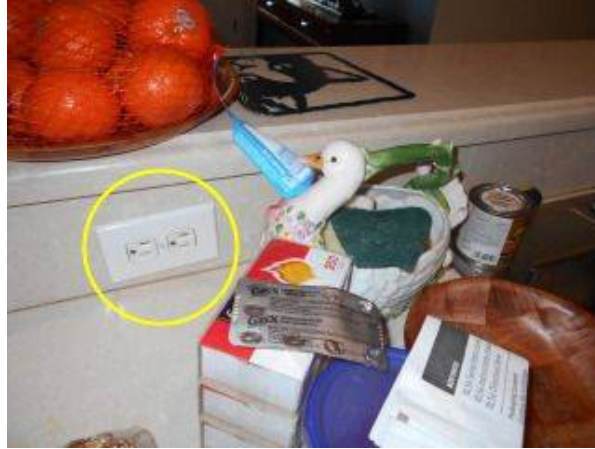
- 4) **+** Outlets in the kitchen area should be protected by GFCI breaker or the outlets themselves could be replaced with GFCI outlets. This is a safety issue. Replacement by qualified electrician is recommended.

Photo 4-2
kitchen sink outlet S/B GFCI

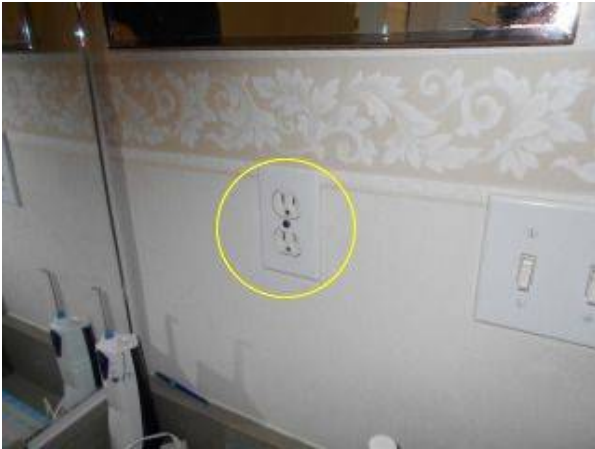
Outlet in the Master bathroom should be GFCI protected. Replacement of outlet by qualified electrician is recommended.

Photo 5-1
M Bath outlet S/B GFCI

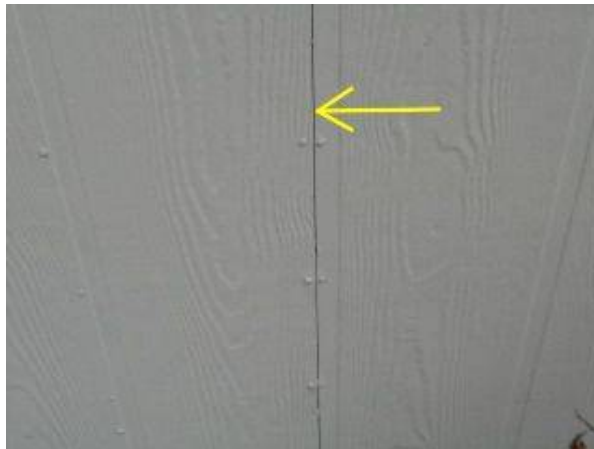
On front elevation of home natural shrinkage has opened minor cracks between siding and trim. Recommend caulking and touch up painting to prevent water intrusion. Rear and side paneling also show minor shrinkage leaving open joints. If contractor applied sealant to overlap of panels this is not an issue. Caulking and touch up is recommended if this status is unknown as a precaution against future water intrusion.

Photo 6-2
Typical shrinkage Hardi panel joints

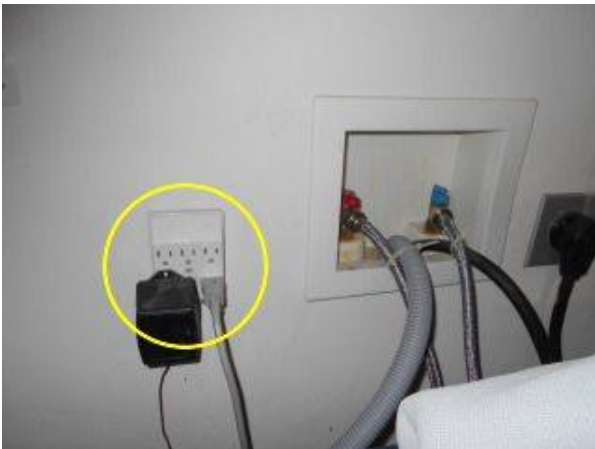
Outlet in garage near washer S/B GFCI protected. Recommend review by qualified electrician.

Photo 9-1
Outlet in garage S/B GFCI

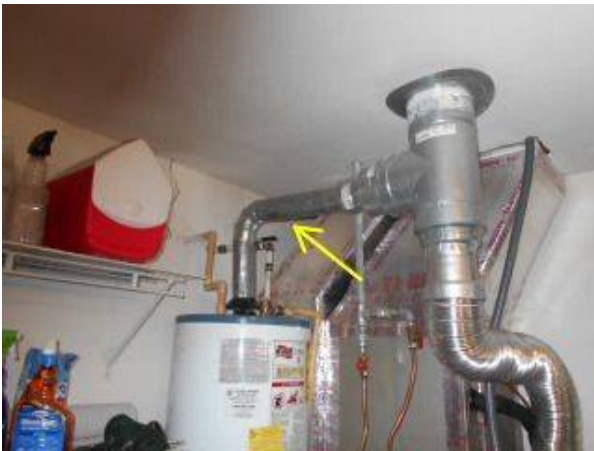
Photo 12-1

Water heater vent ducting has a slight negative pitch. This disturbs natural convection of combustion exhaust gases. Repairs would be easily performed if it is recommended that this be corrected by qualified personnel.

rev pitch on WH vent pipe
