Informed Inspection, Inc.

Town House Inspection

Property address: **4000 nw 20th Avenue
Anytown, FL 32999**

Inspection date: **Thursday, March 17, 2016**

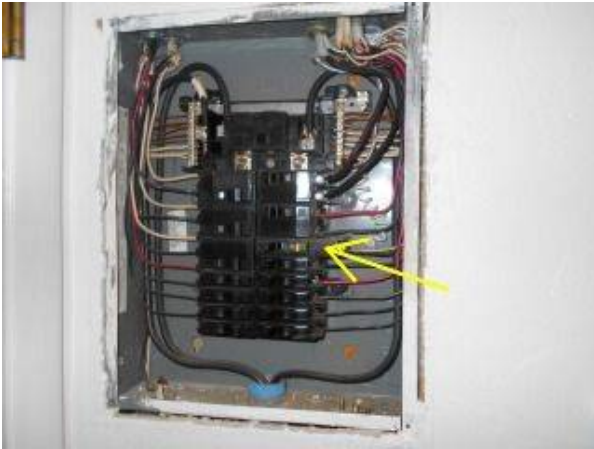
Photo 4-1

4) Unable to verify primary grounding scheme, but system is functioning normally. Wiring was done well. See main breaker box photos for reference. Main panel located in laundry. GFCI breaker used to protect all bathroom and screen porch outlets.

100 A main service panel clean no issues GFCI breaker for bathrooms and rear screen area outlet

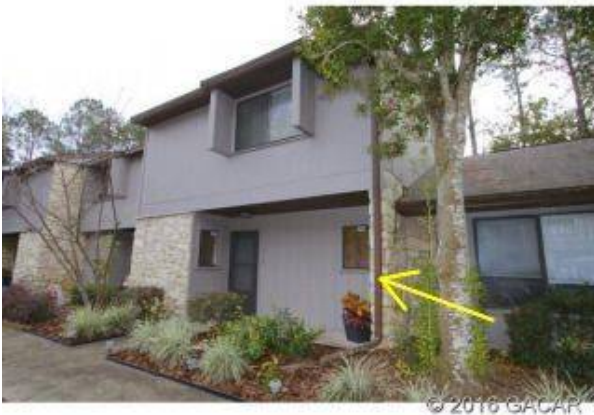
Photo 6-1

front elevation siding well maintained Realtor reports repairs on several loose curled shingles being done after closing. Raining at time of inspection rain water handling working well

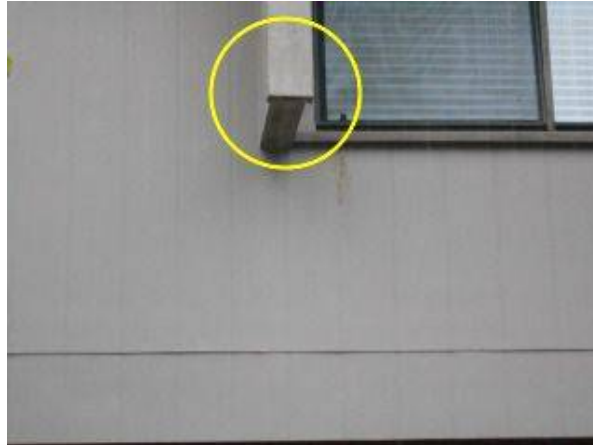
Photo 6-2

Exterior and grounds well maintained. It was raining so I was able to observe rain water handling system performed well. Maintenance issue exists on trim surrounding front 2nd story window. Recommend caulking and painting both sides.

only ext issue noted. Trim separating requires caulking and touch up painting, both sides

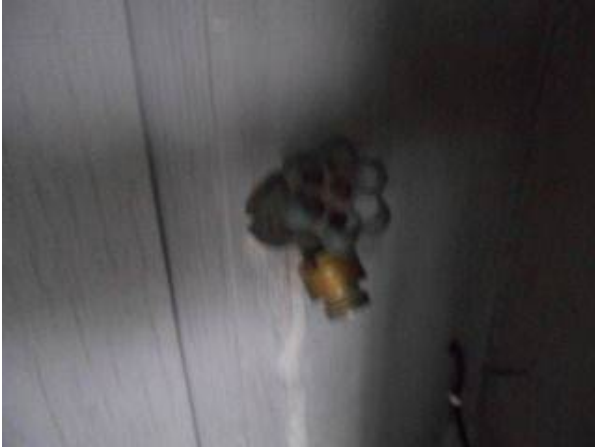
Photo 8-1

Rear screened area, evidence of past leak. Monitor.

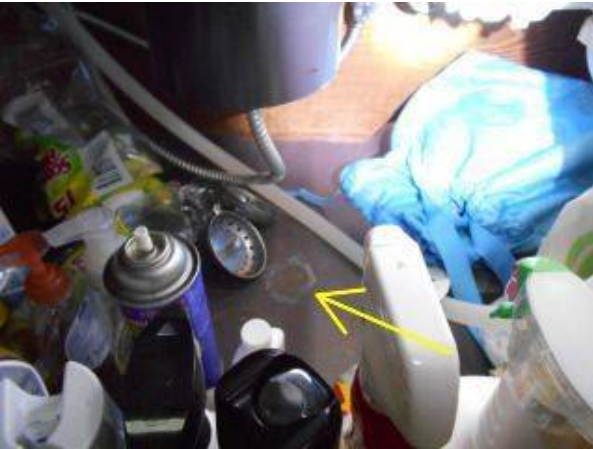
Evidence of past leak under disposal unit. Dry currently recommend that you monitor for possible leak.

Photo 9-1
kitchen sink cabinet evidence of previous leak now dry

Stain found below the disposal. Plumbing leaks may have occurred in the past. Consult with the property owner about this, and imonitor to see if future action is required.

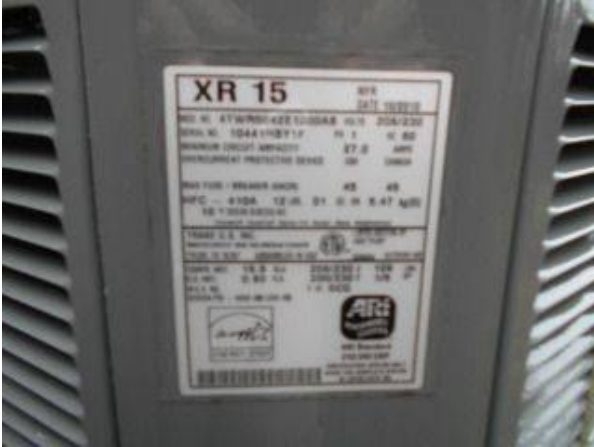
Photo 11-1

- 11) 📸 Heat pump and digital control worked well. 18 degree input to register temp drop measured. Recommend leaves and pine needles in compressor unit be removed at next service.

Trane XR15 heat pump mfg 2010 working well 18 degree input to output air differential

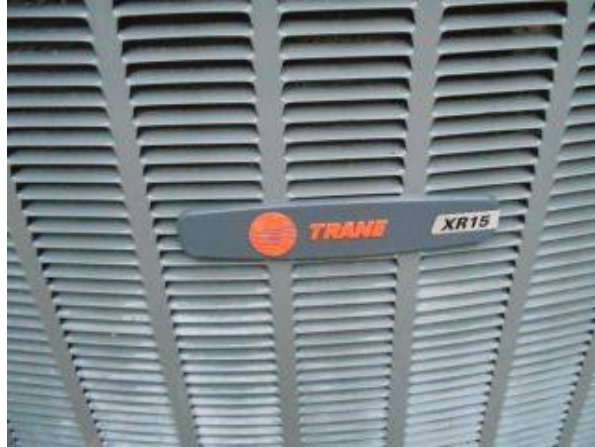
Photo 11-2

heat pump mfg and model

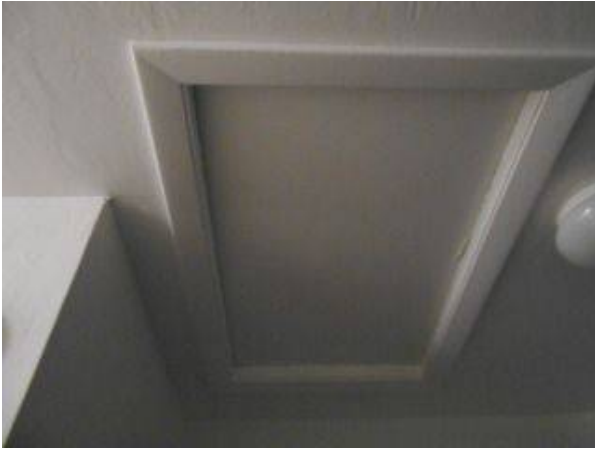
Photo 12-1

12) 🛠️👉 Attic access hatch panel difficult to operate as it is very tight. Recommend trimming edges to allow it to fit more easily.

attic access up stairs hall SE bedroom entrance.
Raining during inspection, no evidence of leaks in attic.
loose fiberglass insulation adequate.

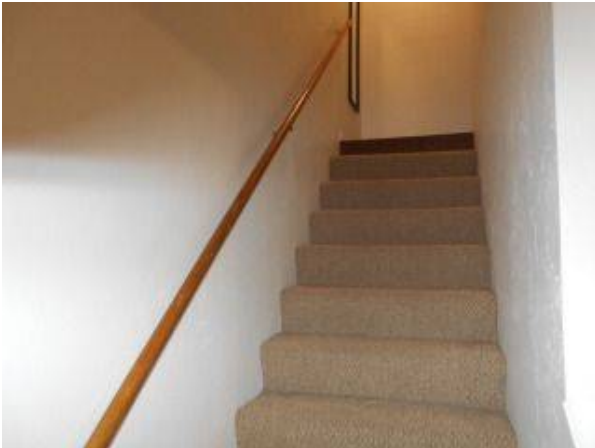
Photo 13-1

stairs carpeted and proper secure handrailing

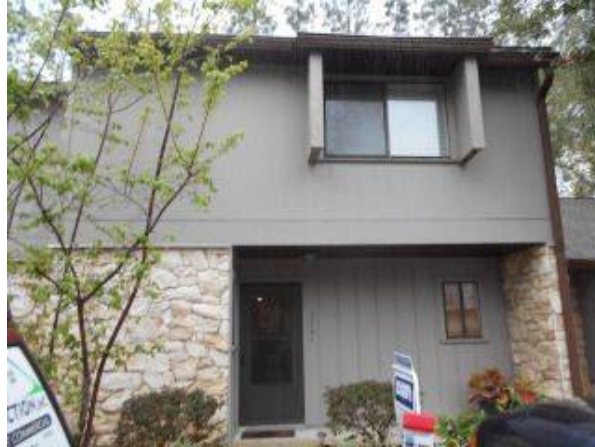
Photo 14-2
well maintained grounds, exterior doors and windows sealed and maintained well.
